Evaluating the experiences with real fire load. Case studies in Hungary

Éva Lublóy, Olivér Czoboly, Viktor Hlavička

Budapest University of Technology and Economics, Department of Construction Materials and Technologies, Budapest, Hungary. Corresponding author: É. Lublóy, lubeva@web.de

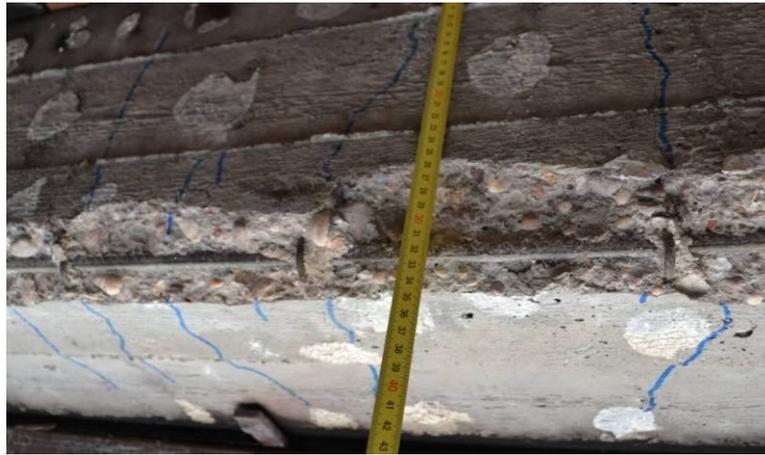
Figure 1. Explosive spalling of the concrete cover by reinforced concrete beam.

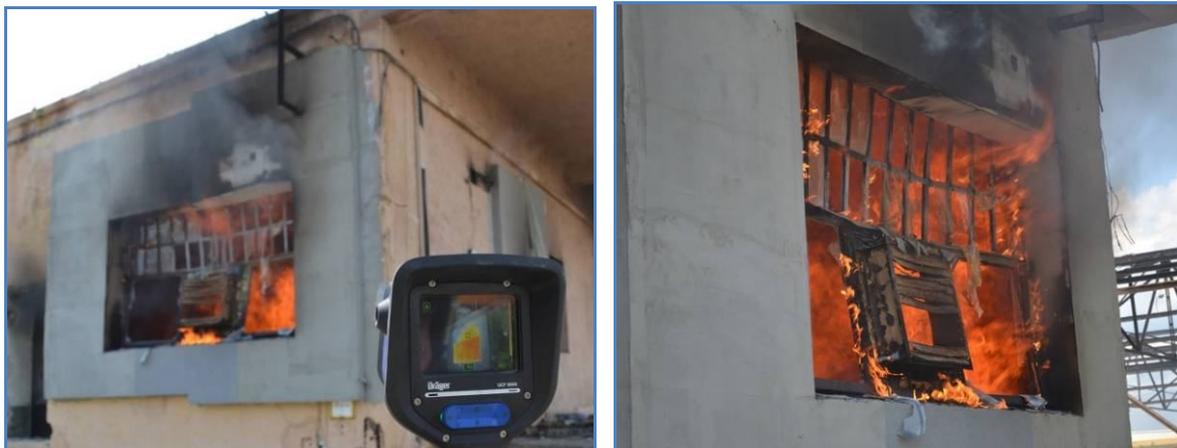
Case study: fire in an industrial hall. A small room (area: 14.7 m² and clear height: 2.5 m) of a reinforced concrete frame warehouse was subjected in 2014 in Kecskemet to a real fire load test (Figure 2). The slab of the test building was cast-in-situ reinforced concrete with nonloadbearing brick walls. We put large amount of combustible materials (paper, rubber, wood) in the test area in order to simulate a real building fire. Thermocouples were placed in the tested area, so we could measure the temperature at 0.3 m distance from the slab. Opening and closing of the door, and influence of a broken window on the fire scenario were also considered. Behaviour of the various building materials and the structural elements were studied during the fire.

Figure 2. Frontage of industrial hall during the fire test (Lublóy at al 2015a).

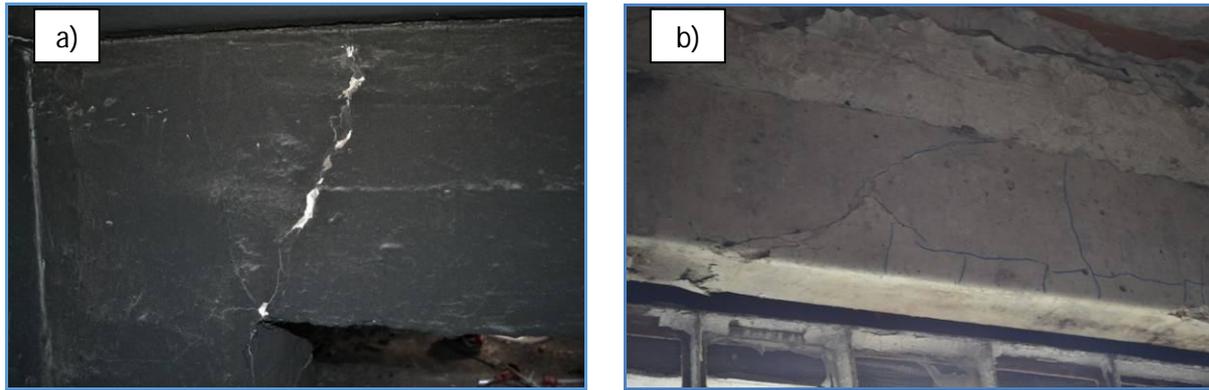
The damage of the joint of concrete beam and pillar was observed far from the centre of the fire caused by cumulative deformations (Figure 3a). Cracks were observed around the longitudinal reinforcements and stirrups on the concrete cover of the lintel (Figure 3b). The carbonation zone was less than the concrete cover. The test of the carbonation zone is important for fire cases because of the decomposition of Ca(OH)_2 at 500°C. This means that the temperature of the reinforcement was lower than 500°C. It may be explained by the thick concrete cover and the relatively short fire effect.

Figure 3. Damaged concrete elements, a) effects of cumulative deformation the joint of the concrete beam and pillar, b) cracks on the lintel (Lublóy at al 2015a).

In case of fire in an industrial hall, cracks were observed far from the centre of the fire caused by cumulative deformations and cracks were observed around the longitudinal reinforcements and stirrups on the concrete cover of the lintel.

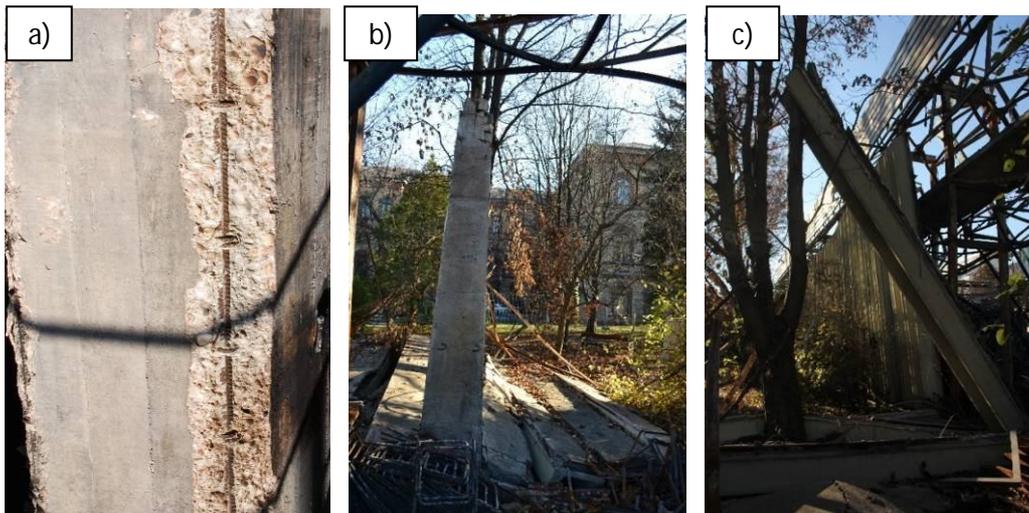
At some locations the temperature of the reinforced concrete was higher than 500°C (Lublóy at al 2015b). Explosive spalling of the concrete cover was observed on the pillars and the beams (Figure 4a). Stability failure of precast concrete wall elements and slab elements occurred, due to the failure of the steel elements (Figure 4b and Figure 4c).

Figure 4. a) Explosive spalling of the concrete cover, b) and c) stability failure of concrete elements (Lublóy at al 2015b).

In case of the Athletic Hall of the University of Physical Education in Budapest, explosive spalling of the concrete cover was observed on the pillars and the beams and stability failure of precast concrete wall elements and slab elements was caused by the failure of the steel elements.

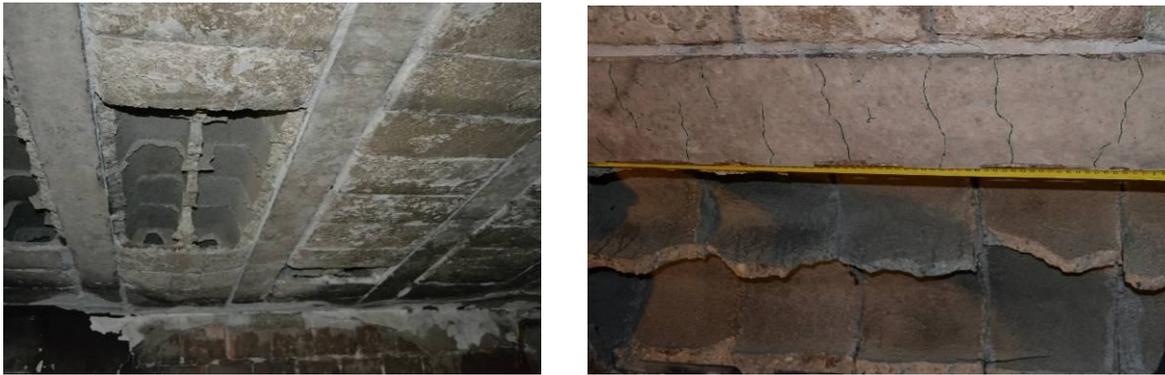
Case studies: slab-interjoists systems. The slab in our case studies consisted of pretensioned E type girders and concrete interjoists were made without reinforcement. Due to the fire the slab was damaged (Figure 5) some of the pretensioned E-girders were cracked (Balázs & Lublóy 2015). The concrete became red-coloured, indicating that the maximum temperature was around 500°C. The bottom parts of concrete interjoists fall down.

Figure 5. Fire damage of the girder-slab with concrete interjoists (Balázs & Lublóy 2015).

In case of slab-interjoists systems, the slabs were damaged due to the fire. Some of the pretensioned E-girders were cracked. The concrete became red-coloured, indicating that the maximum temperature was around 500°C. The bottom parts of the concrete and the brick interjoists fall down.

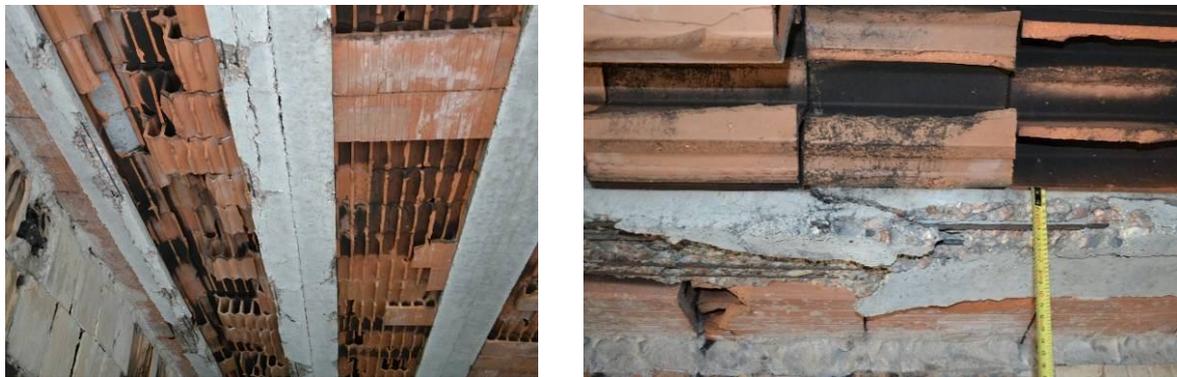
During the fire case in one furniture store, the concrete cover of the pretensioned E type girders was spalled (Figure 6). The concrete was white-coloured and strongly cracked indicating that the temperature reached about 800°C. The bottom parts of brick interjoists fall down.

Figure 6. Fire damage of the girder-slab with brick interjoists (Balázs & Lublóy 2015).
